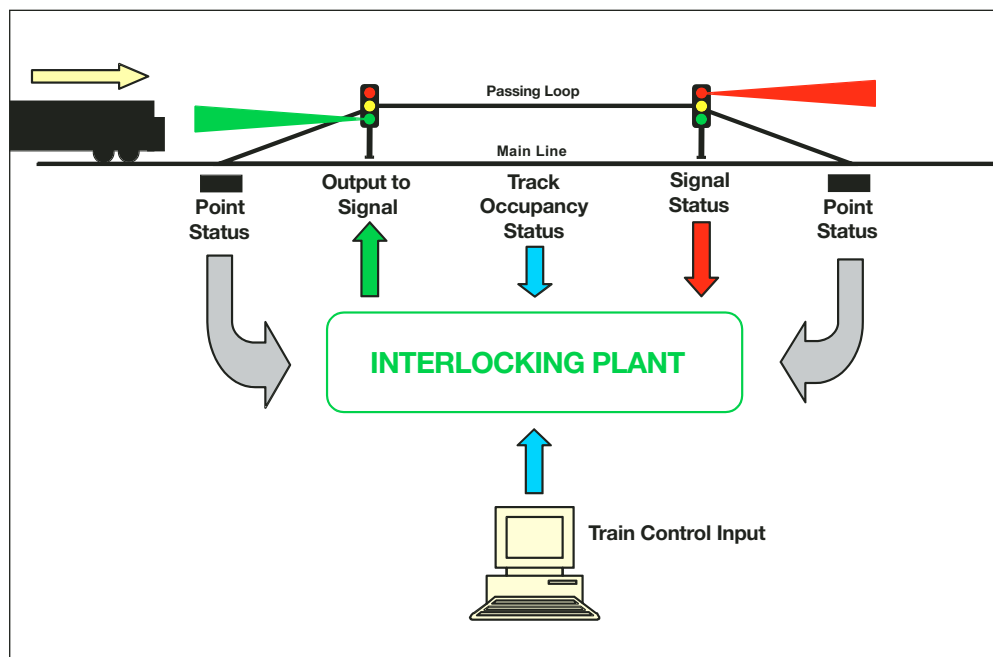
FIGURE 17: Elements of Railway Signalling Plant

The fundamentals of railway signalling (Fig. 17) have not substantially changed with time and are intended to:

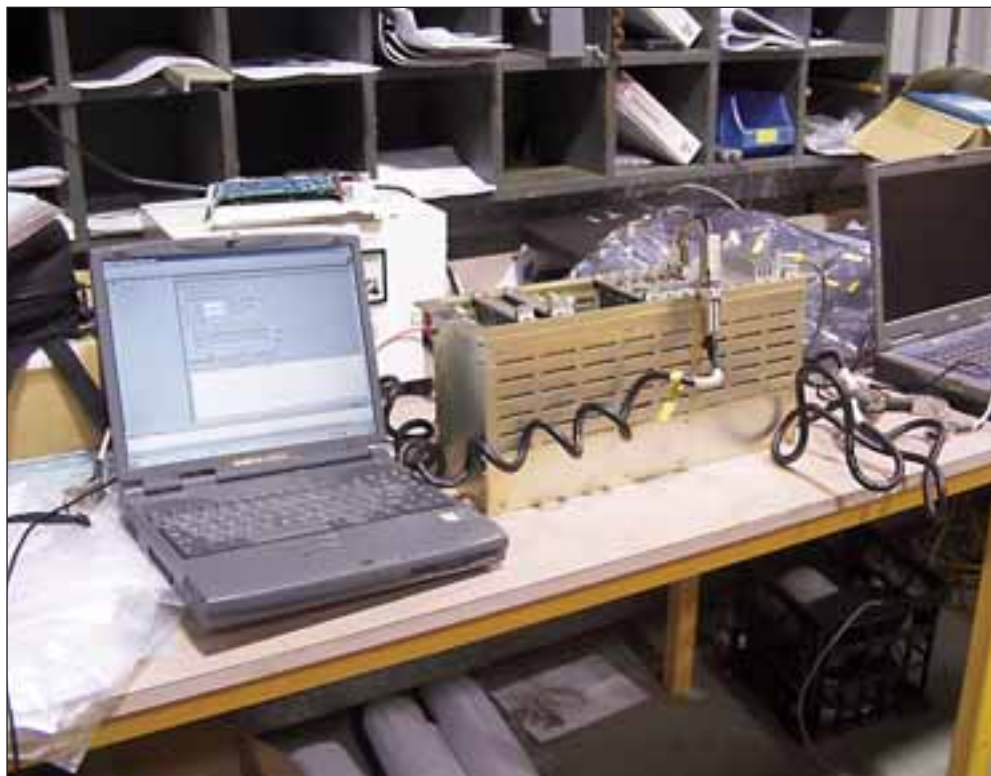
FIGURE 18: Power Car CPU Rack – Data Download

These cards were extracted and transported in the presence of Queensland Police to Brisbane for analysis. On arrival in Brisbane, the data cards were inserted into a 'Power Car CPU Rack' to enable downloading (Fig. 18) and subsequent analysis.
